1. Grounds, Driveways & Walkways

1.4 Deck Findings

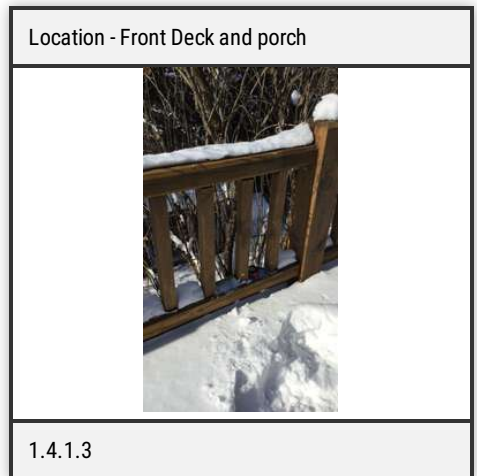
1.4.1 Balusters too far apart

Balusters should be no more than 4 inches apart for safety. Recommend professional contractor correction.

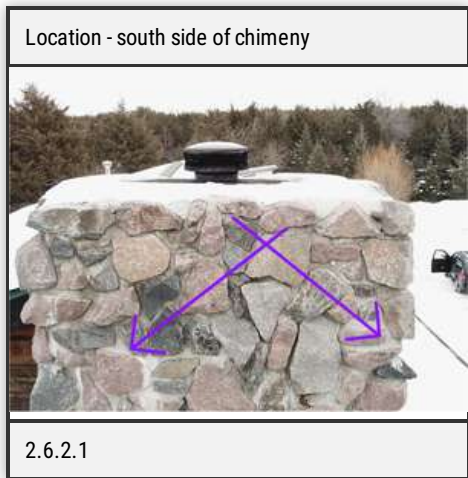
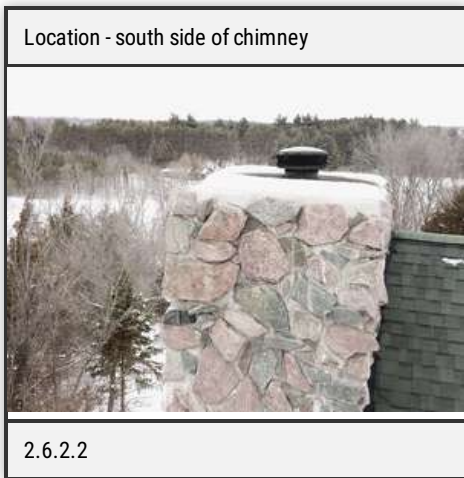
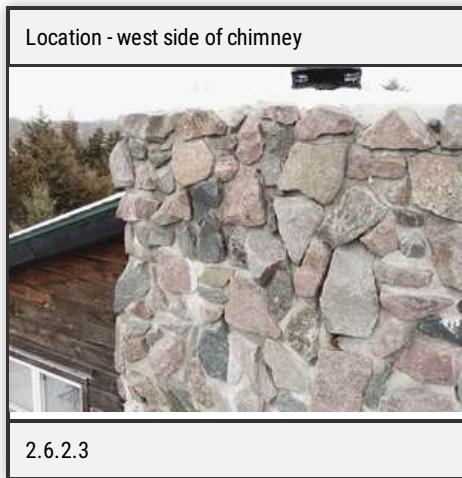
2.6.2 chimney concrete cracks

Some separation of cement and stone. Recommend qualified chimney sweep inspect and repair as needed
